Manhole Inspection Summary

Manhole # S55U__D01MH

Location Address: **1800 s. clinton**

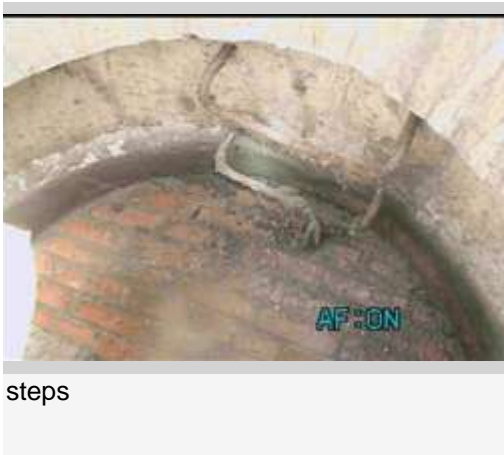
Defect 1

Count: **2** Missing: **0** ☒ **Corroded**

steps

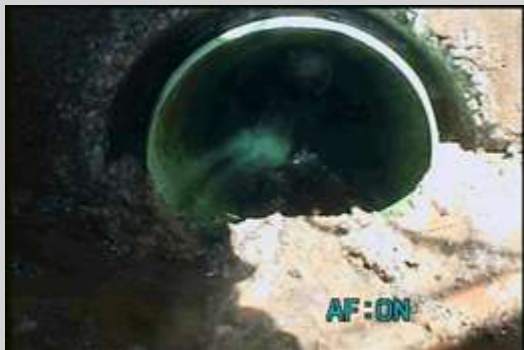
12 O'Clock Outflow

8 in. Circular Gravity Sewer
Pipe Out @ 12 O'Clock
